Streak Artifacts due to Change in Reconstruction Parameters in CT in PET-CT Image Acquisition

Homi Bhabha Cancer Hospital & Research Centre, Visakhapatnam, India

Our department has a positron emission computed tomography (PET-CT) scanner (Model discovery IQ 5 ring, s/n 083045206656219). We encountered an artifact on the thoracic and pelvic region of Tran's axial CT images in the PET-CT scan of each patient throughout the day. Which were showed near spiral streaks across Tran's axial images? On careful examination and in particular viewing CT images in bone and abdominal window, it became apparent that the streaks in the Trans axial slices were spiral at thoracic and pelvic region. The remaining slices did not show this kind of artifacts. The artifact persistent on the CT scan even after cleaning of the mylor window with warm water or disinfect solution. We felt that the possible reason for the artifact could be due to defect in the collimation of X-rays.

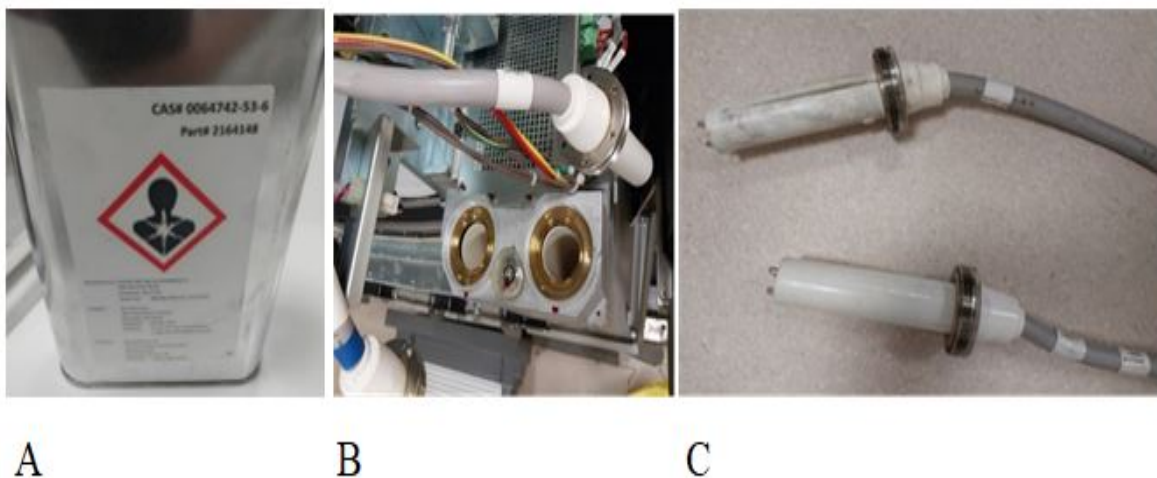
Figure 1: a) Dielectric Oil b) placement zone c) HV cathode cables

We immediately made a call to service engineer and find insufficient dielectric oil [Figure :1(a)] and while opening CT gantry for filling the dielectric oil to the CT tubes he found breakdown at the HV cathode cable [Figure 1c]. Immediately placed an order for the spare part and replaced it on an emergency basis. After that service engineer done all CT QA and QC calibration procedures but later we again found the same artifacts on the CT Trans axial images

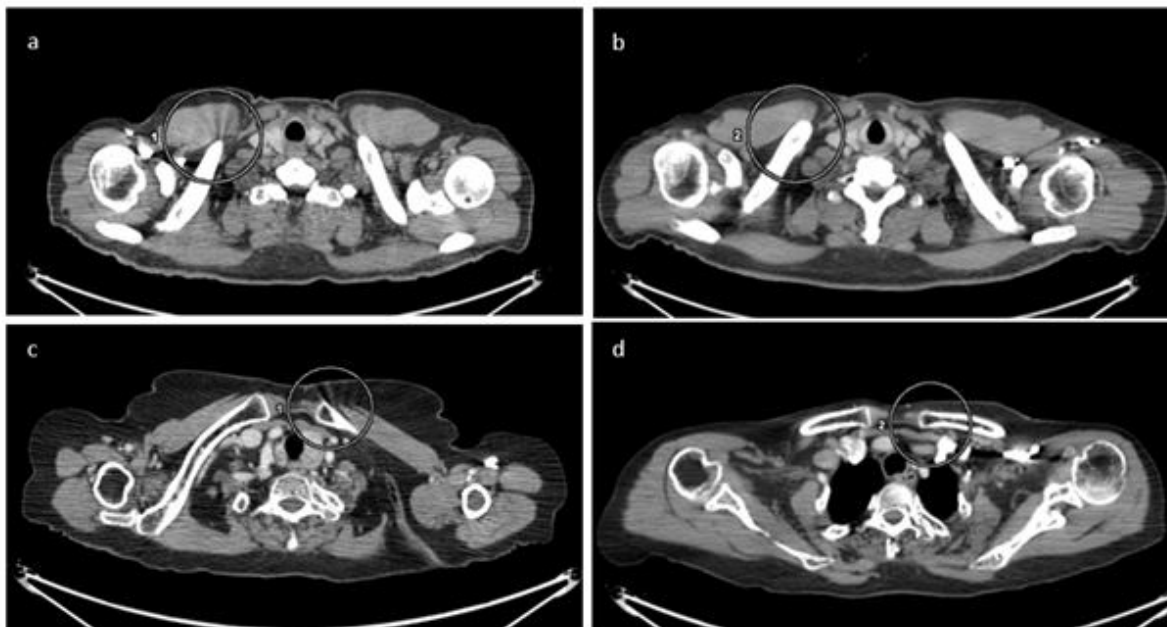
of all CT and PET-CT scan-based patients. Then GE engineer suspected on the CT acquisition, reconstruction methods and we decided to review the CT parameters like scan type, rotation time, recon mode, recon type, pitch, noise index and all. Our review revealed difference in CT reconstruction type and rotation time.

In the earlier protocol the standard recon type and rotation time was 0.6sec with standard recon mode which

was now changed to soft recon type, IQ enhance recon mode with rotation time of 0.7sec.

Figure 2: (a)&(c) axial images of two different patients showing streaking artifacts at clavicle bone (encircled) and (b)&(d) axial images of same patients after changing parameters

the detector module, CT hardware parts and also not much of significant down time. This type of artifacts can be avoided by maintaining locking system of the standard protocols prescribed by the manufacturer.

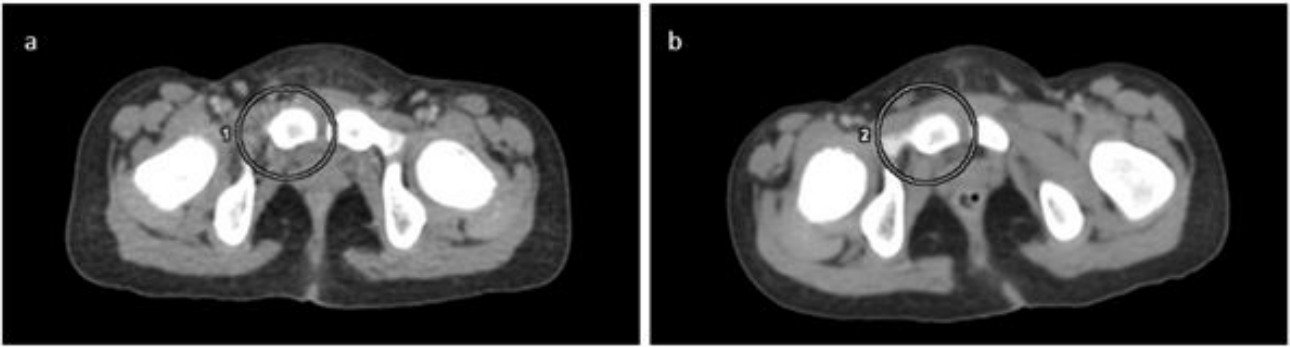
Figure 3: (a) axial image of another patient showing streaking artifact at right pubic bone (encircled) and (b) axial image of the same patient after changing parameters
